## MANUFACTURING METHODS TECHNOLOGY (MM&T) FOR BALLISTICALLY TOLERANT REPLACEMENT FLIGHT CONTROL COMPONENTS

Rune Anderson  
Whittaker Corporation  
Research and Development Division  
San Diego, Calif. 92123

July 1974

Final Report for Period May 1972 - February 1974

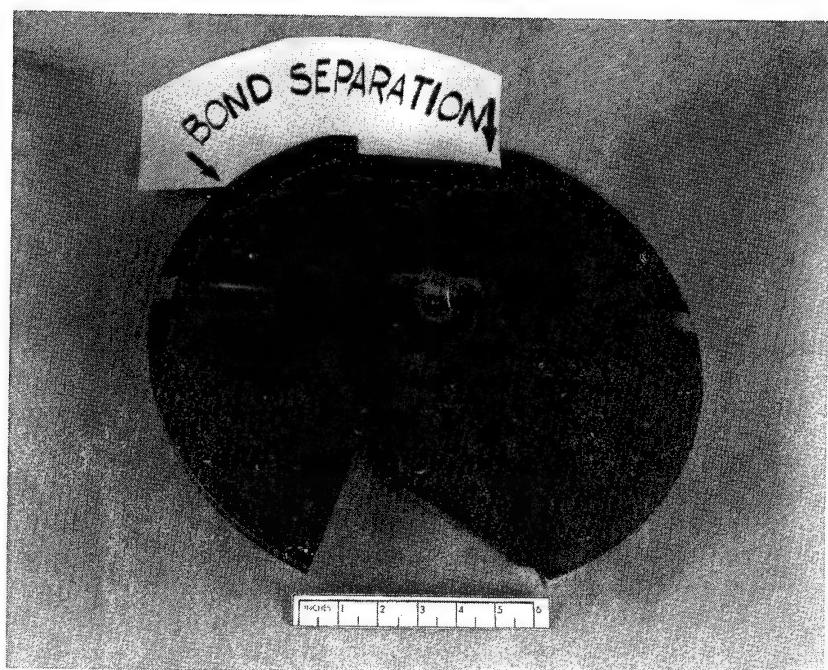
The lower disc was severely charred and the surface was distorted in the area that ignited. The peripheral bond between the lower and upper discs had separated over a distance of 9 in. in the

area where the cables are attached to the quadrant. The BMC material in the molded upper disc and fittings was only slightly discolored and did not appear to be damaged (Figure 28).

Figure 28. Quadrant After Fire Test.

Due to the damage on the lower disc of the quadrant it was decided to apply a thermal protection coating to one of the earlier rejected lower quadrant discs and retest it separately for fire resistance. A 0.030-in.-thick coating (two coats) of 410-1A thermal protection coating was applied to the disc in accordance with NASA Tech Brief 70-10450. The coated lower quadrant disc was placed horizontally approximately 8 in. above the burner. After 1 minute and 45 seconds, it burned slightly, but the flames self-extinguished when the disc was raised approximately 12 in. The disc was immediately lowered again and held over the burner for 15 seconds to complete the 2-minute test. When removed, the disc was burning slightly, and when the flames did not self-extinguish after 5 seconds they were put out.

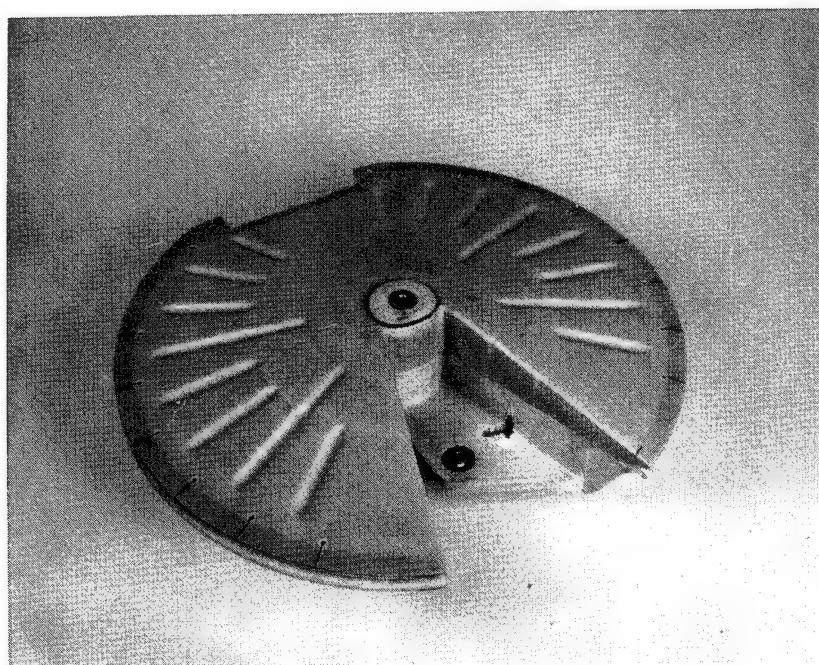
Figure 41. Quadrant After .30 Caliber Test -  
Impact Side.

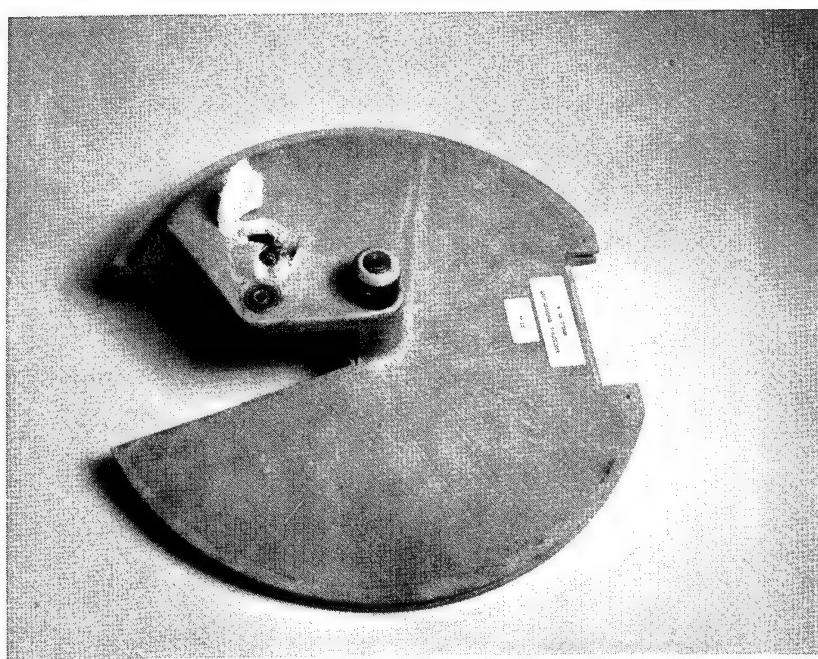
Figure 42. Quadrant After .30 Caliber Test -  
Exit Side.

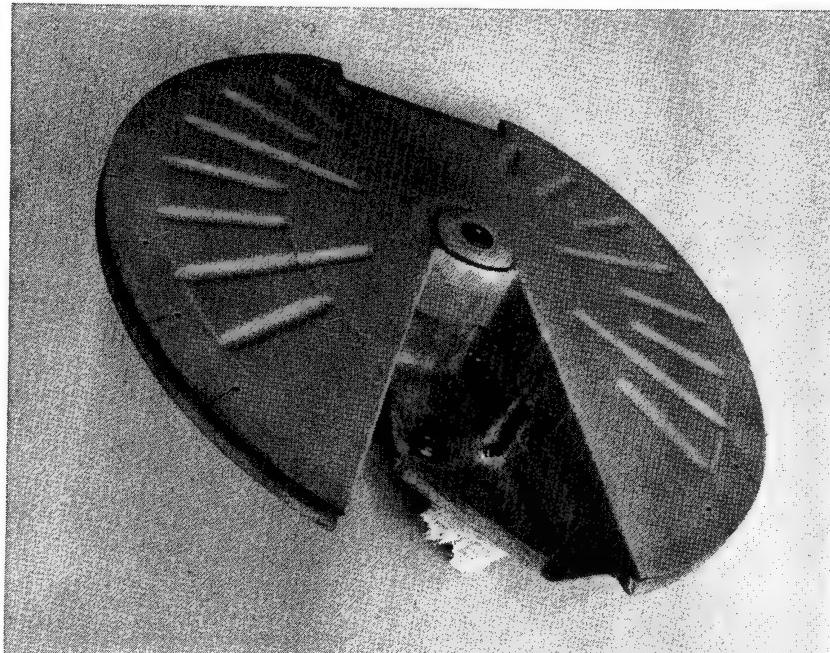
Figure 43. Quadrant After .50 Caliber Test -  
Impact Side.

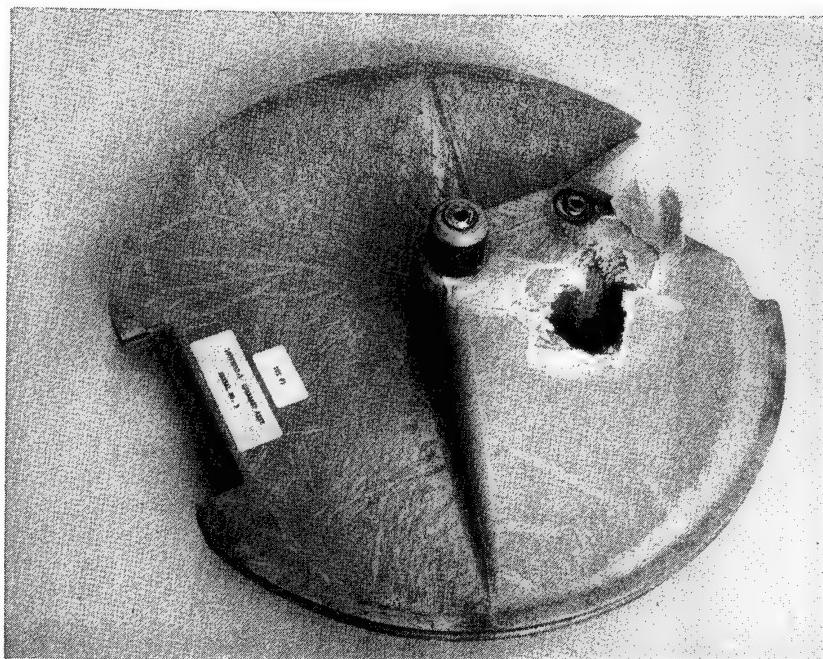
Figure 44. Quadrant After .50 Caliber Test -  
Exit Side.

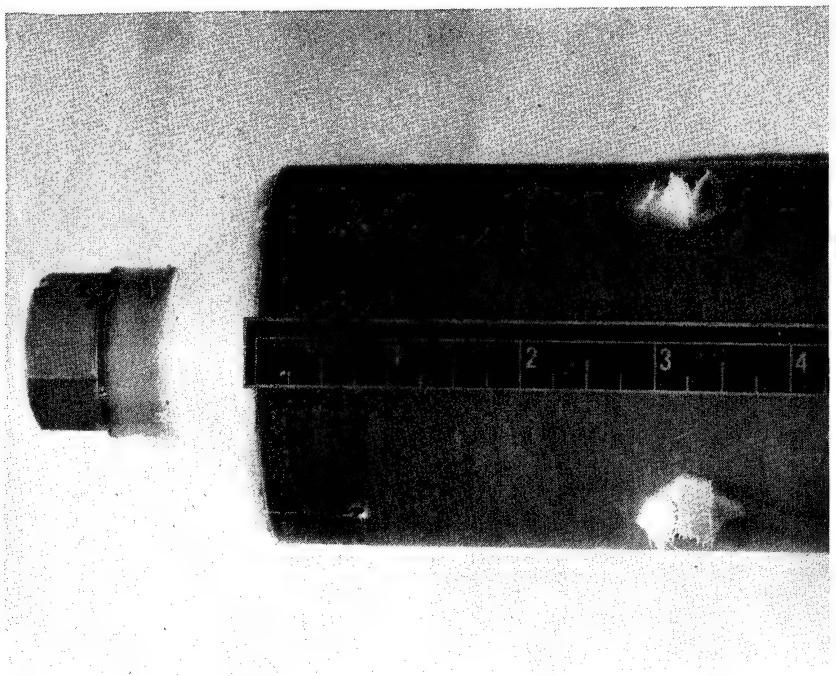
Figure 45. Connecting Link After .50 Caliber Test.

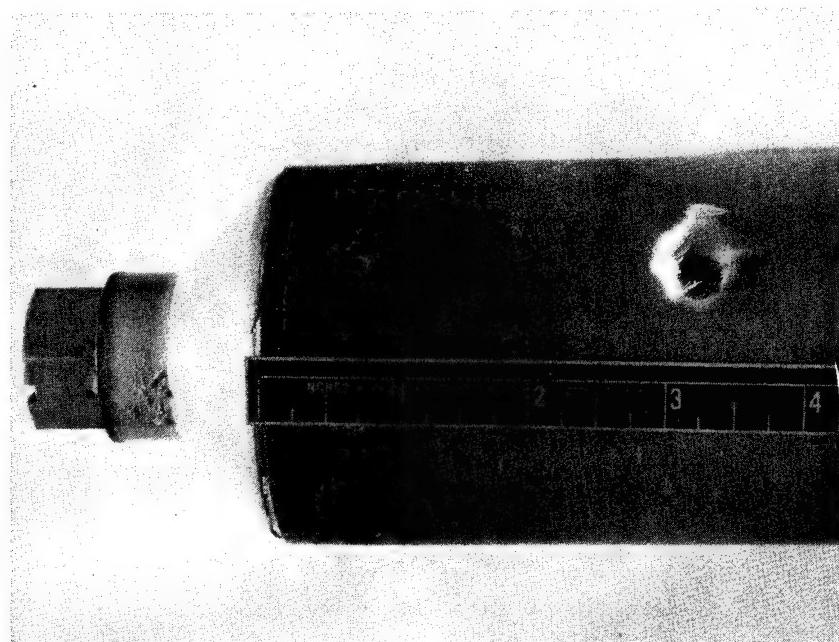
Figure 46. Connecting Link After .50 Caliber Test -  
Exit Side.

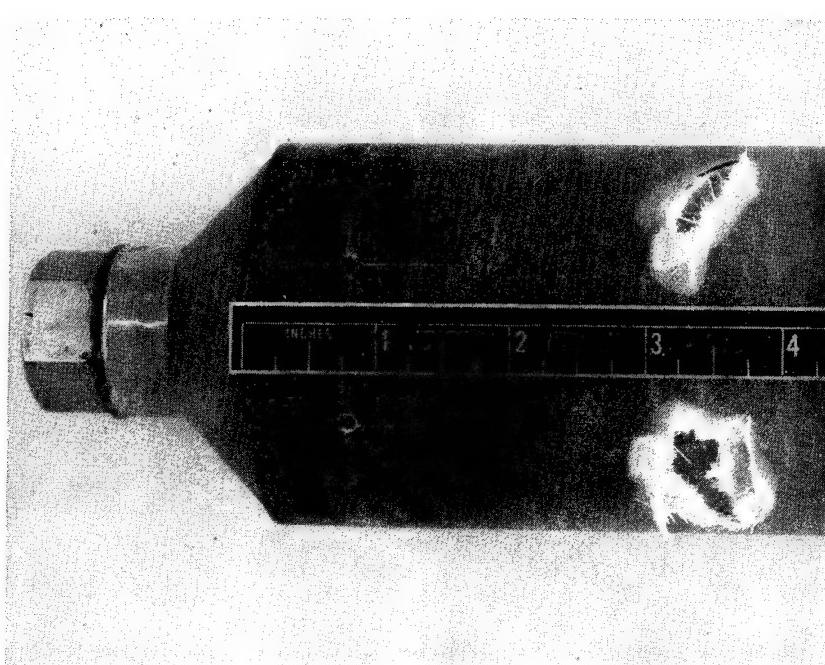
Figure 47. Connecting Link After .30 Caliber Test.

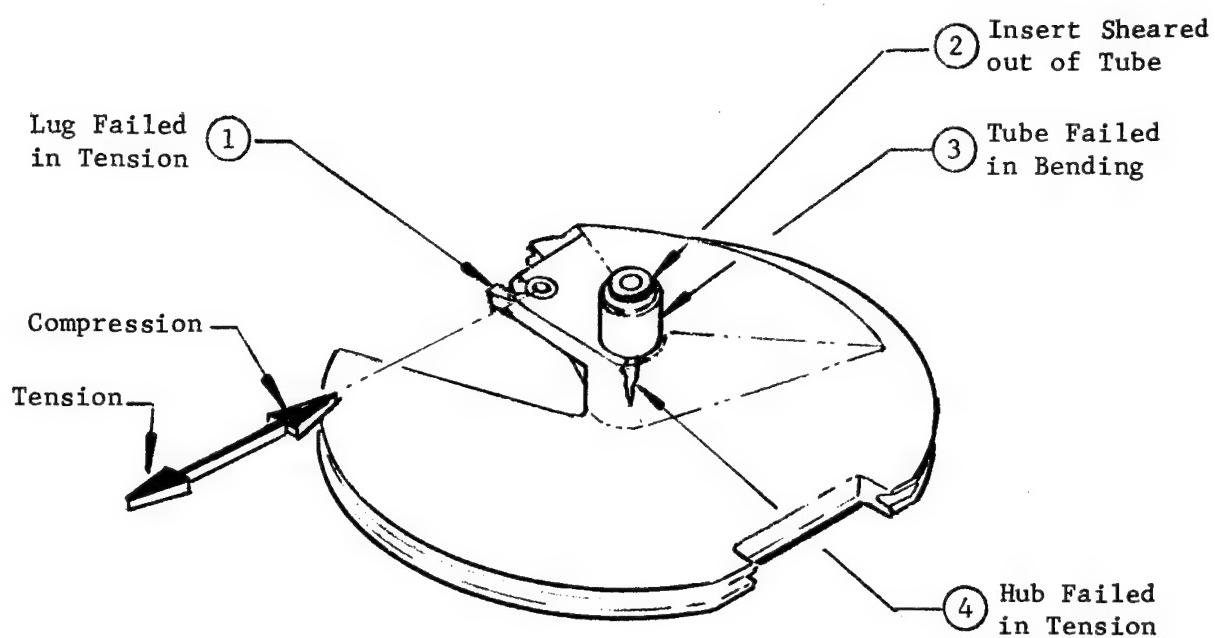
Figure 50. Summary of Static Failure/Deflection Tests of Quadrant.

The quadrant of set no. 1 failed at 2350 lb, or 177% of proof load, and the quadrant of set no. 2 failed at 1820 lb, or 137% of proof load. Based on these results it was decided to test the remaining quadrants in the same manner as set no. 2 with the rod in tension. A summary of the tests with description of failures is shown in Figure 50. It appears that the lower failure load of set no. 2 may be due to the fuel and oil test, which it was subjected to prior to the ultimate load test, rather than the direction in which it was tested. The summary in Figure 50 shows that with the exception of set no. 2 the failure loads are approximately the same for either loading direction. Figures 51, 52, and 53 show the different modes of failure of the quadrant.

Set	Type Load	Failure Load (lb)	% of Proof Load	Deflection at Failure Load* (in.)	Type of Failure
1	Compression	2350	177	.17	(3) -
2	Tension	1820	137	.15	(1) Fig. 51
3	Tension	2680	202	.23	(1) Fig. 51
4	Compression	2880	217	.24	(4) Fig. 52
5	Compression	2550	192	.22	(4) Fig. 52
6	Tension	2600	196	.17	(1) Fig. 51
7	Tension	2980	225	.20	(3) -
8	Tension	3120	235	.20	(2) Fig. 53

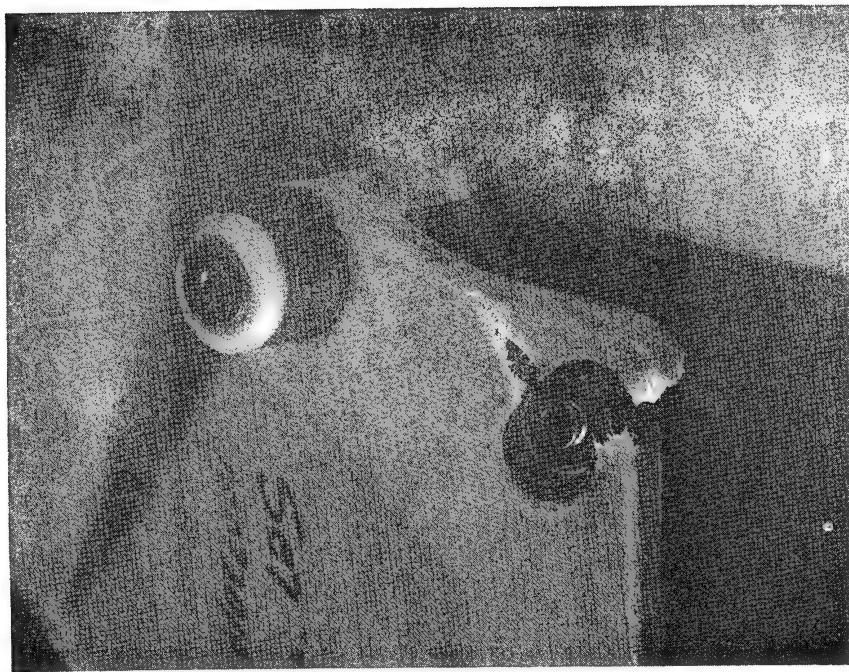
Figure 51. Static Failure Load Test -  
Quadrant - Lug Tension  
Failure.

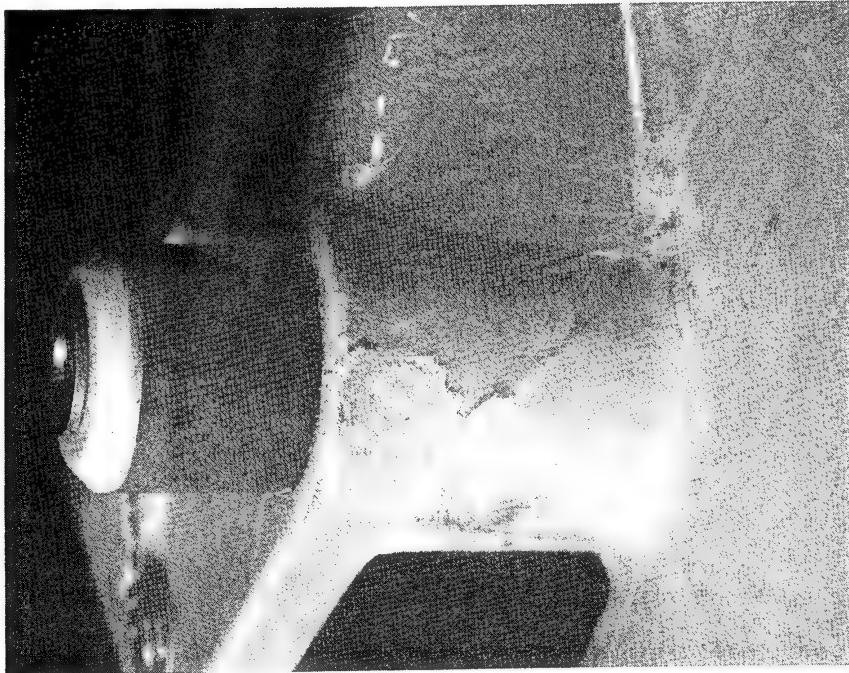
Figure 52. Static Failure Load Test -  
Quadrant - Hub Tension  
Failure.

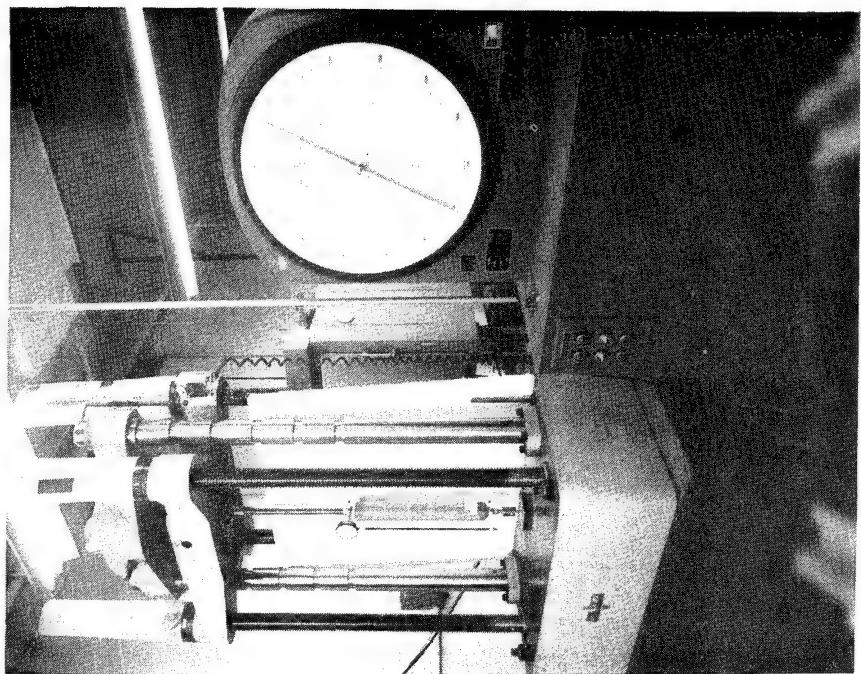
Figure 54. Static Failure Load Test  
of Connecting Link.

The connecting link was mounted in the test fixture shown in Figure 54. The indicator dial was used only for calibrating the x-y recorder on which the deflection was recorded and monitored continuously throughout the test. The deflection was measured between the two metallic end fittings.

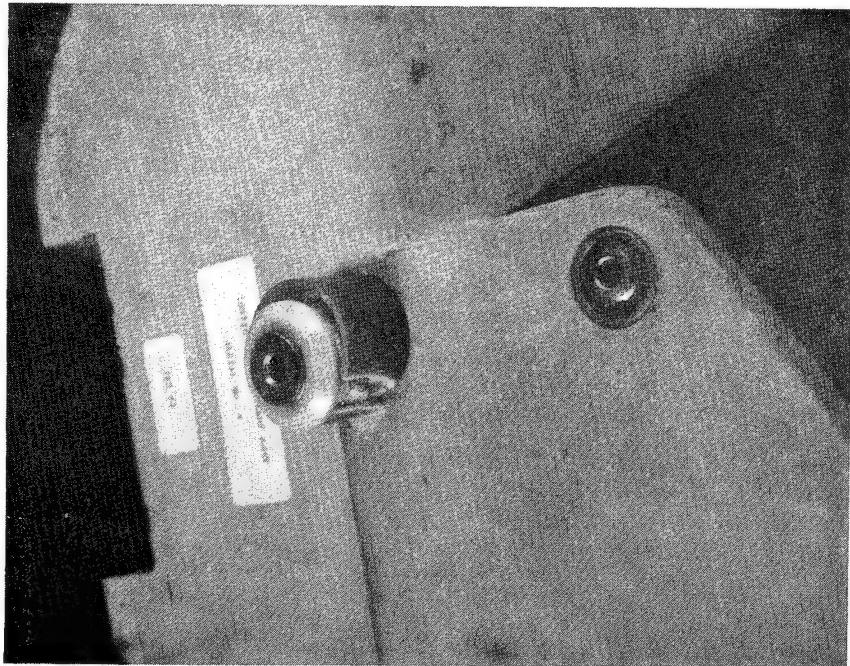
Figure 53. Static Failure Load Test -  
Quadrant - Upper Insert  
Tear-Out.

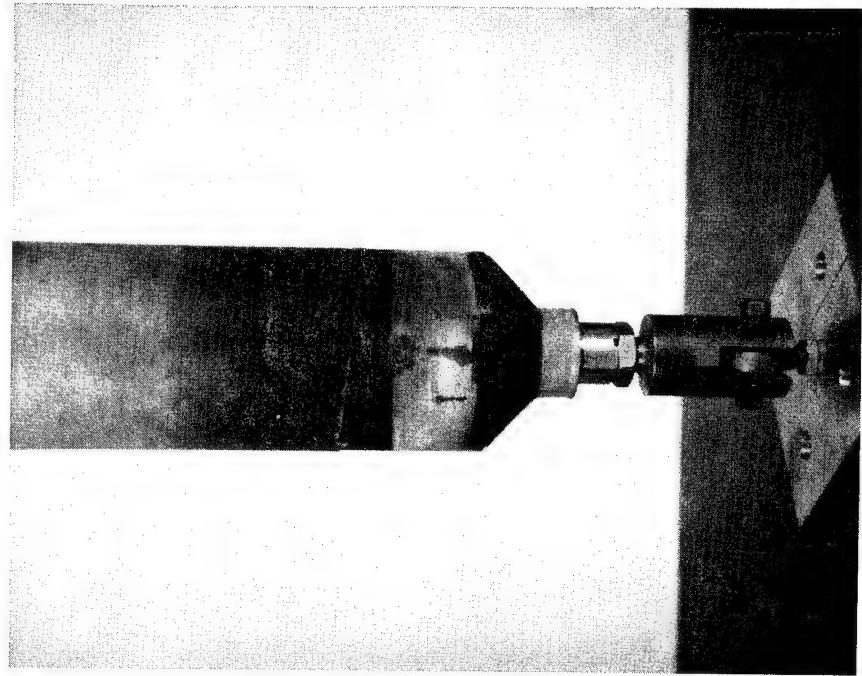
resistance test failed in compression of the outer tube in the burned area. Two connecting links did not fail. The lower rod end failed in bending for set no. 2, and set no. 7 deflected laterally and the test was stopped when the load did not increase and the load/deflection curve flattened out. The tests are summarized in Table 7.

Figure 56. Outer Tube Failed in Compression in Burned Area. Set No. 3.

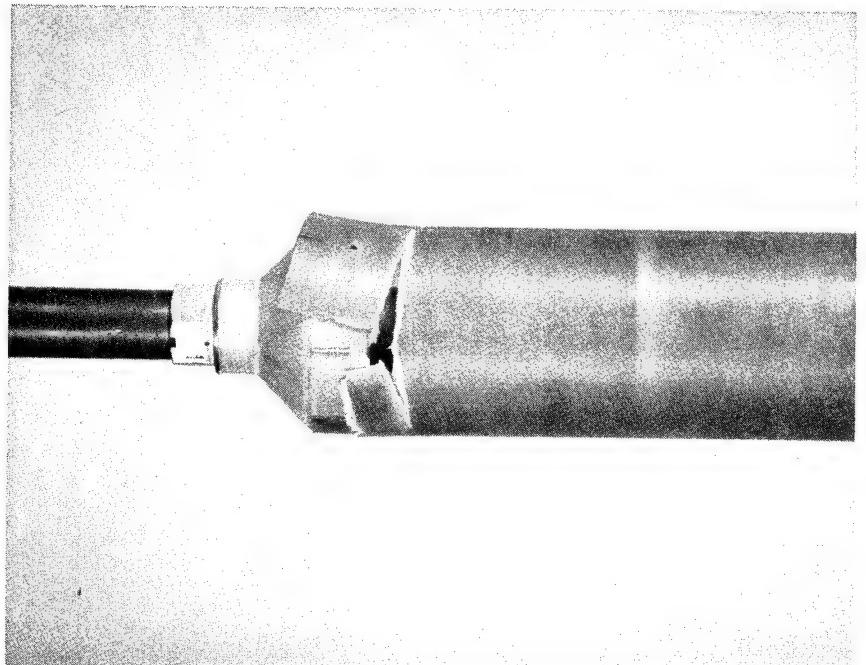
There were three different types of failures. Connecting links from sets 1, 6, and 8 failed when the bond between the outer tube and the upper fitting sheared, and subsequently split the outer tube. The links with ballistic impact damage failed in compression in the damaged area, and the link that had been subjected to the fire

Figure 55. Shear Failure of Bond Between Outer Tube and End Fitting. Typical for Sets 1, 6, and 8.

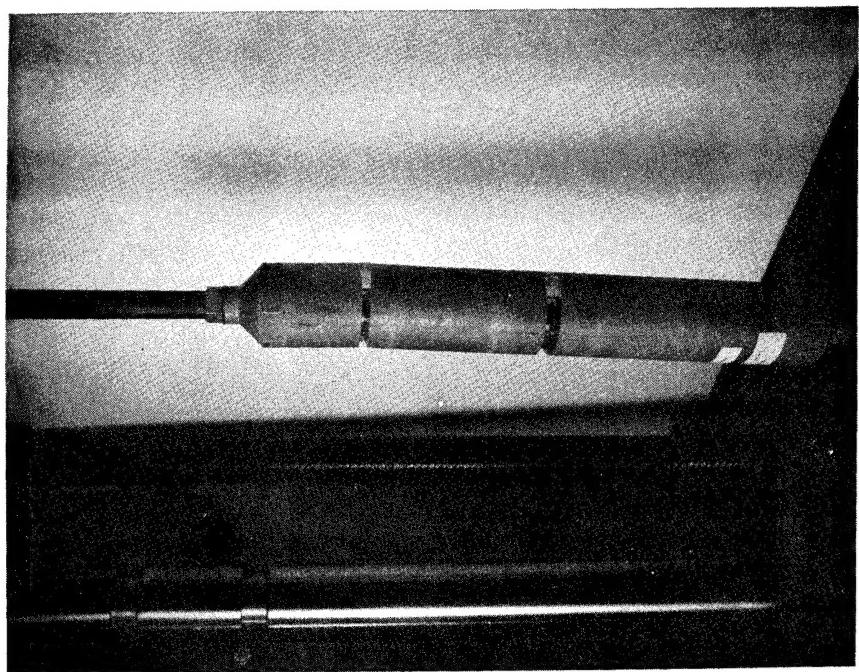
Figure 57. Outer Tube Failed in Compression  
in Area Damaged by Ballistic  
Impact. Sets 4 and 5.

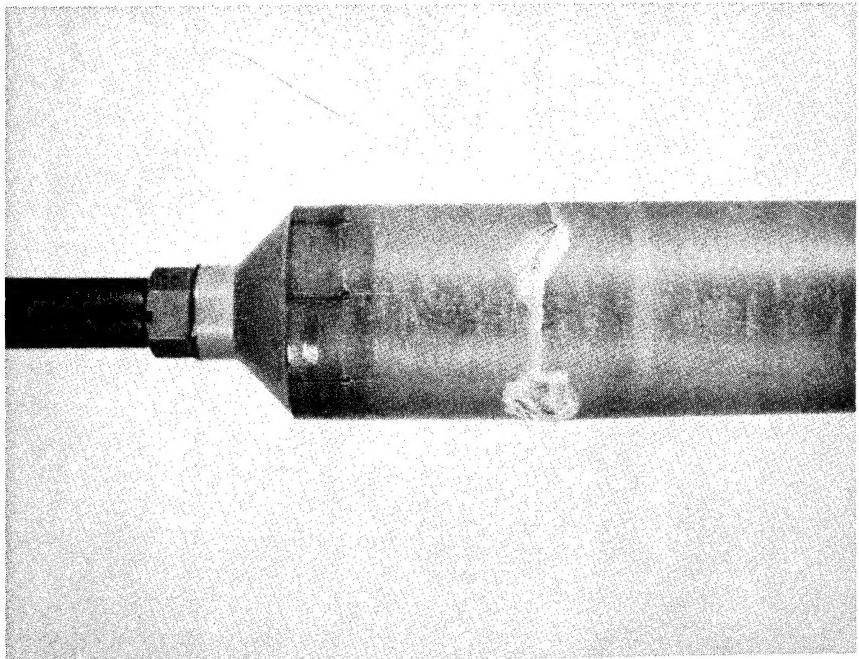
Figure 58. Failed Connecting Link With  
Simulated Ballistic Damage.
